Commission Education Item – Technical Services Department

Marshfield Utilities Home Energy Audit Program Description

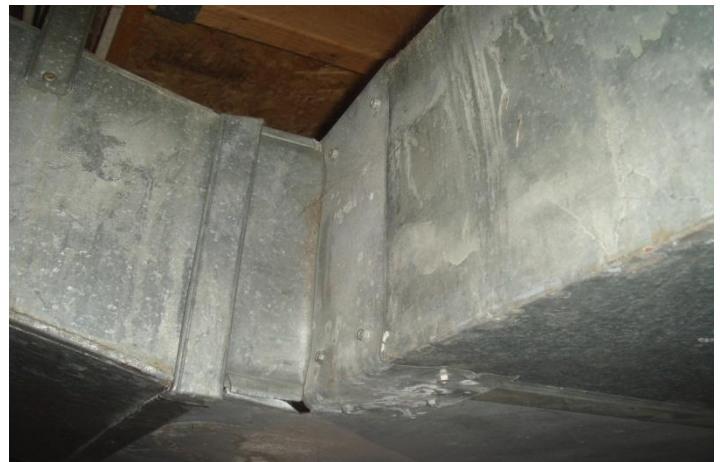
Leaking duct work

We check the overall condition of the heating system in the home. The average forced air heating system life is between 20 and 21 years of age. We check the furnace filter(s). Are they being changed on a regular basis? Are they put in properly? We follow up on the duct work. Is the duct work properly sealed? Should aluminum foil tape be applied to properly seal the duct work? Is the duct work properly attached to the floor/wall registers? Are the dampers in the proper position? Should the furnace be replaced, repaired, or tuned up?
